WORK INSTRUCTIONS

Model: VPRO

Subject: Solution Coupler Replacement

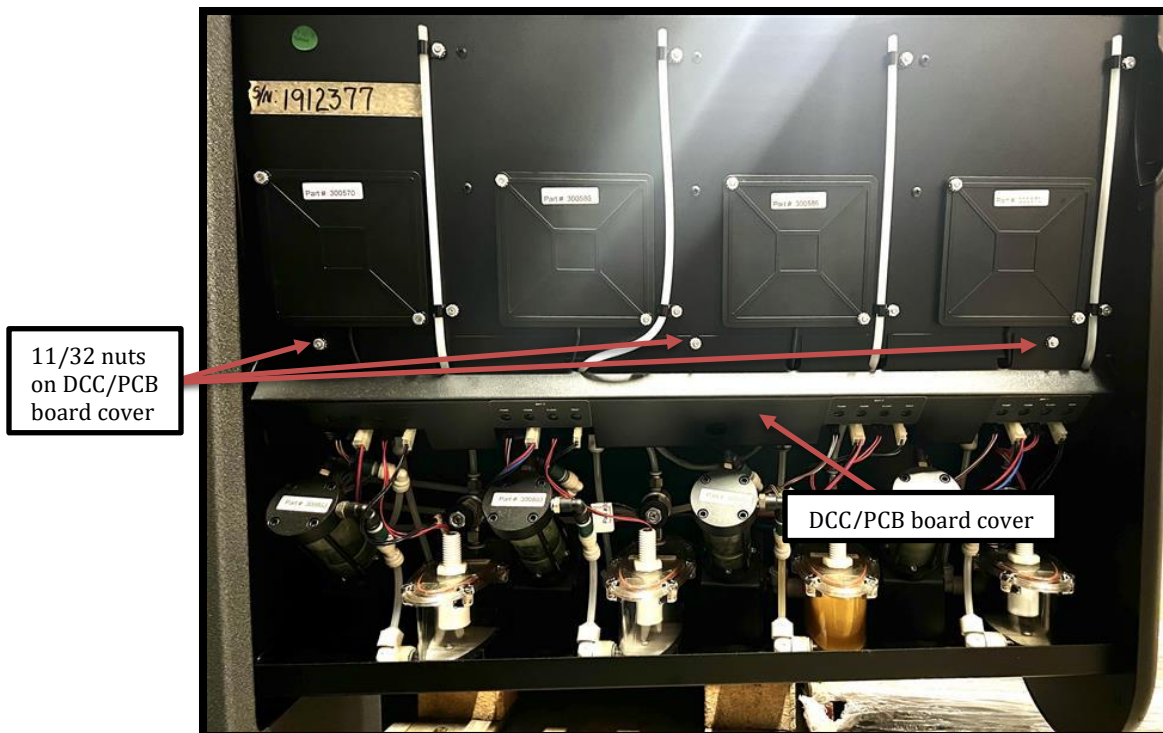
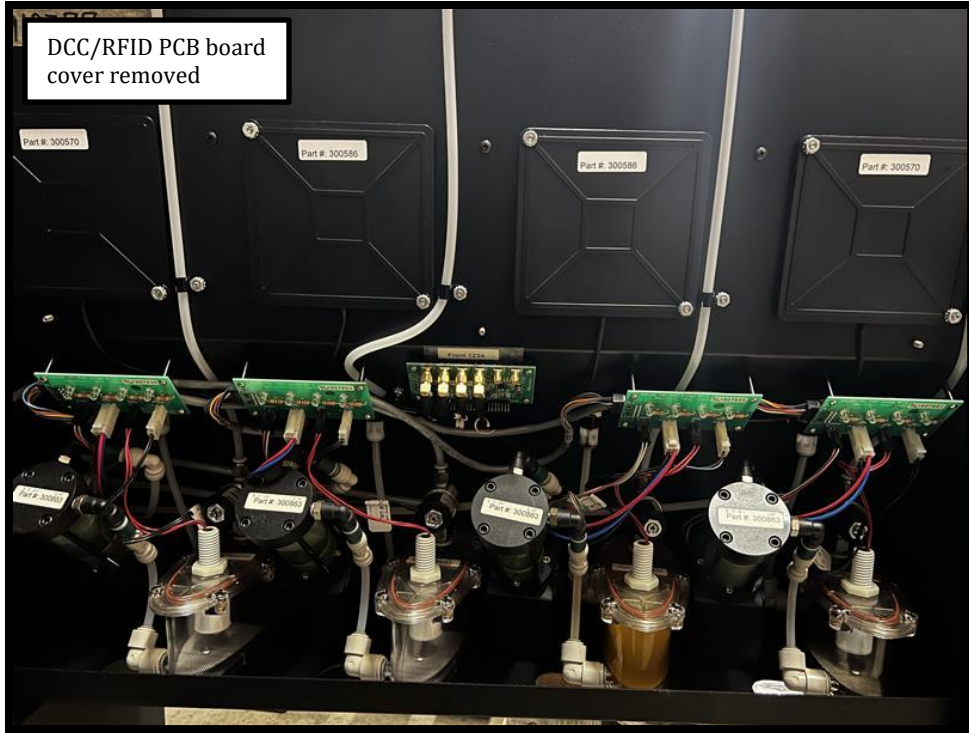
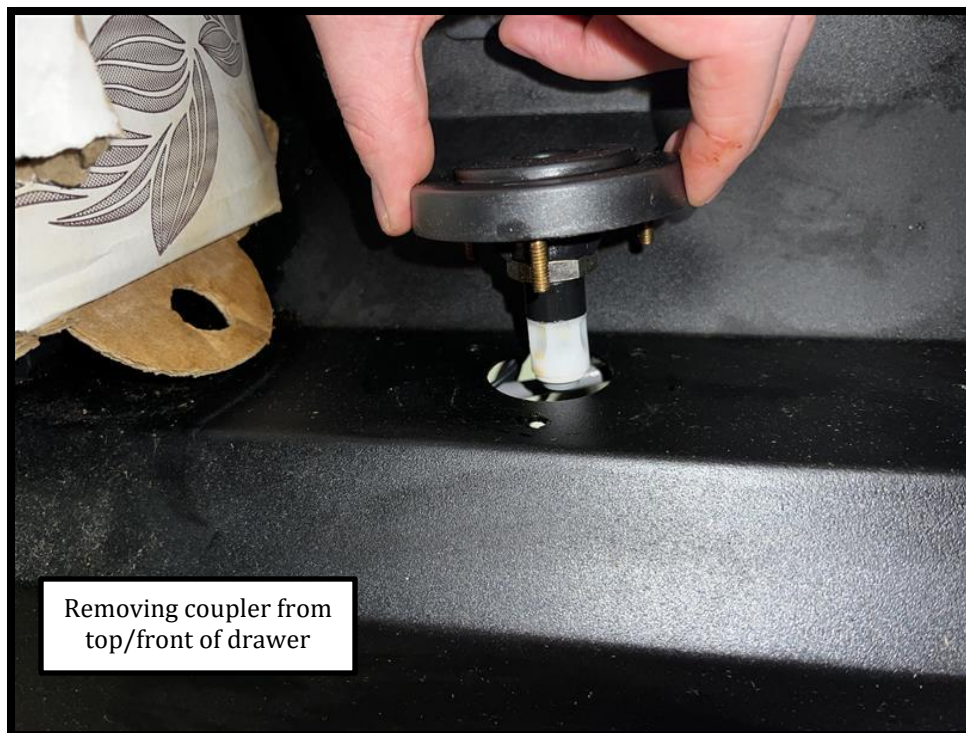
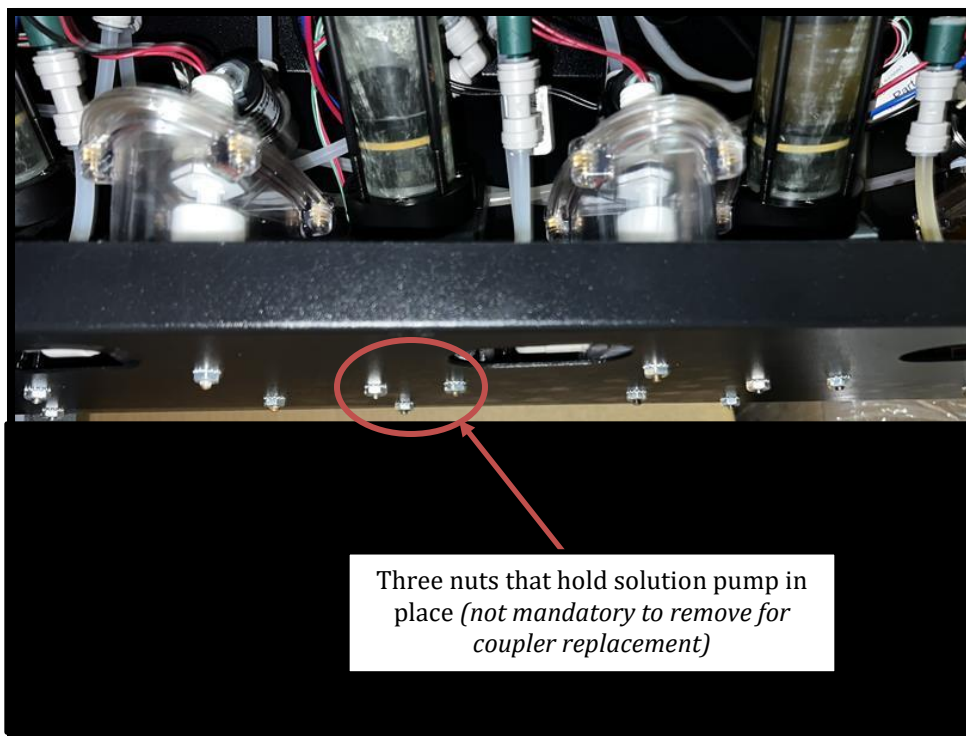
Photos:

1. Open the solution drawer.
 - a. On the Dashboard, select **Unlock Drawer** (upper-left), then pull the drawer open.
2. Remove the bag-in-box (BIB) from the coupler you are replacing.
3. With the BIB removed, move to the opposite side of the solution drawer.
4. Loosen or remove the three 11/32 in. nuts securing the DCC/RFID PCB cover to the solution drawer.
 - a. Removing the cover provides better access to the bottom of the couplers.
5. Locate the solution coupler and disconnect the hose from the push-lock fitting.
 - a. If access is tight, loosen (or remove) the solution pump for additional clearance.
 - i. To loosen the solution pump, carefully remove the three nuts holding it in place on the bottom of the solution drawer. (Page. 5)
6. Remove the three nuts securing the coupler using an 11/32 in. nut driver or socket wrench.
 - a. See page 4 for nut locations.

7. Remove the old coupler from the top of the solution drawer (where the BIB connects).
 - a. **Note:** If the coupler is stuck due to solution buildup, gently wipe around it with a damp cloth to help release it.
8. Install the new solution coupler and secure it with the three nuts you removed.
9. Reconnect the coupler hose to the push-lock fitting.
10. Reinstall the BIB and inspect the coupler for leaks.
 - a. Leaks typically indicate the hose is not fully seated in the push-lock fitting.
11. Reinstall the DCC/RFID PCB cover (if removed) and tighten the three nuts.
12. Return the booth to service.
